**CAPITAL PROGRAM PRIORITY ADVISORY COMMITTEE
REGULAR MEETING
MONDAY, OCTOBER 6, 2025 – 5 p.m.
TOWN HALL MEETING ROOM
5:00 P.M.**

**TOWN OF GRANBY
CAPITAL PROGRAM PRIORITY ADVISORY COMMITTEE
SPECIAL MEETING MINUTES
DECEMBER 2, 2024**

GRANBY MEMORIAL HIGH SCHOOL TRACK & FIELD IMPROVEMENTS

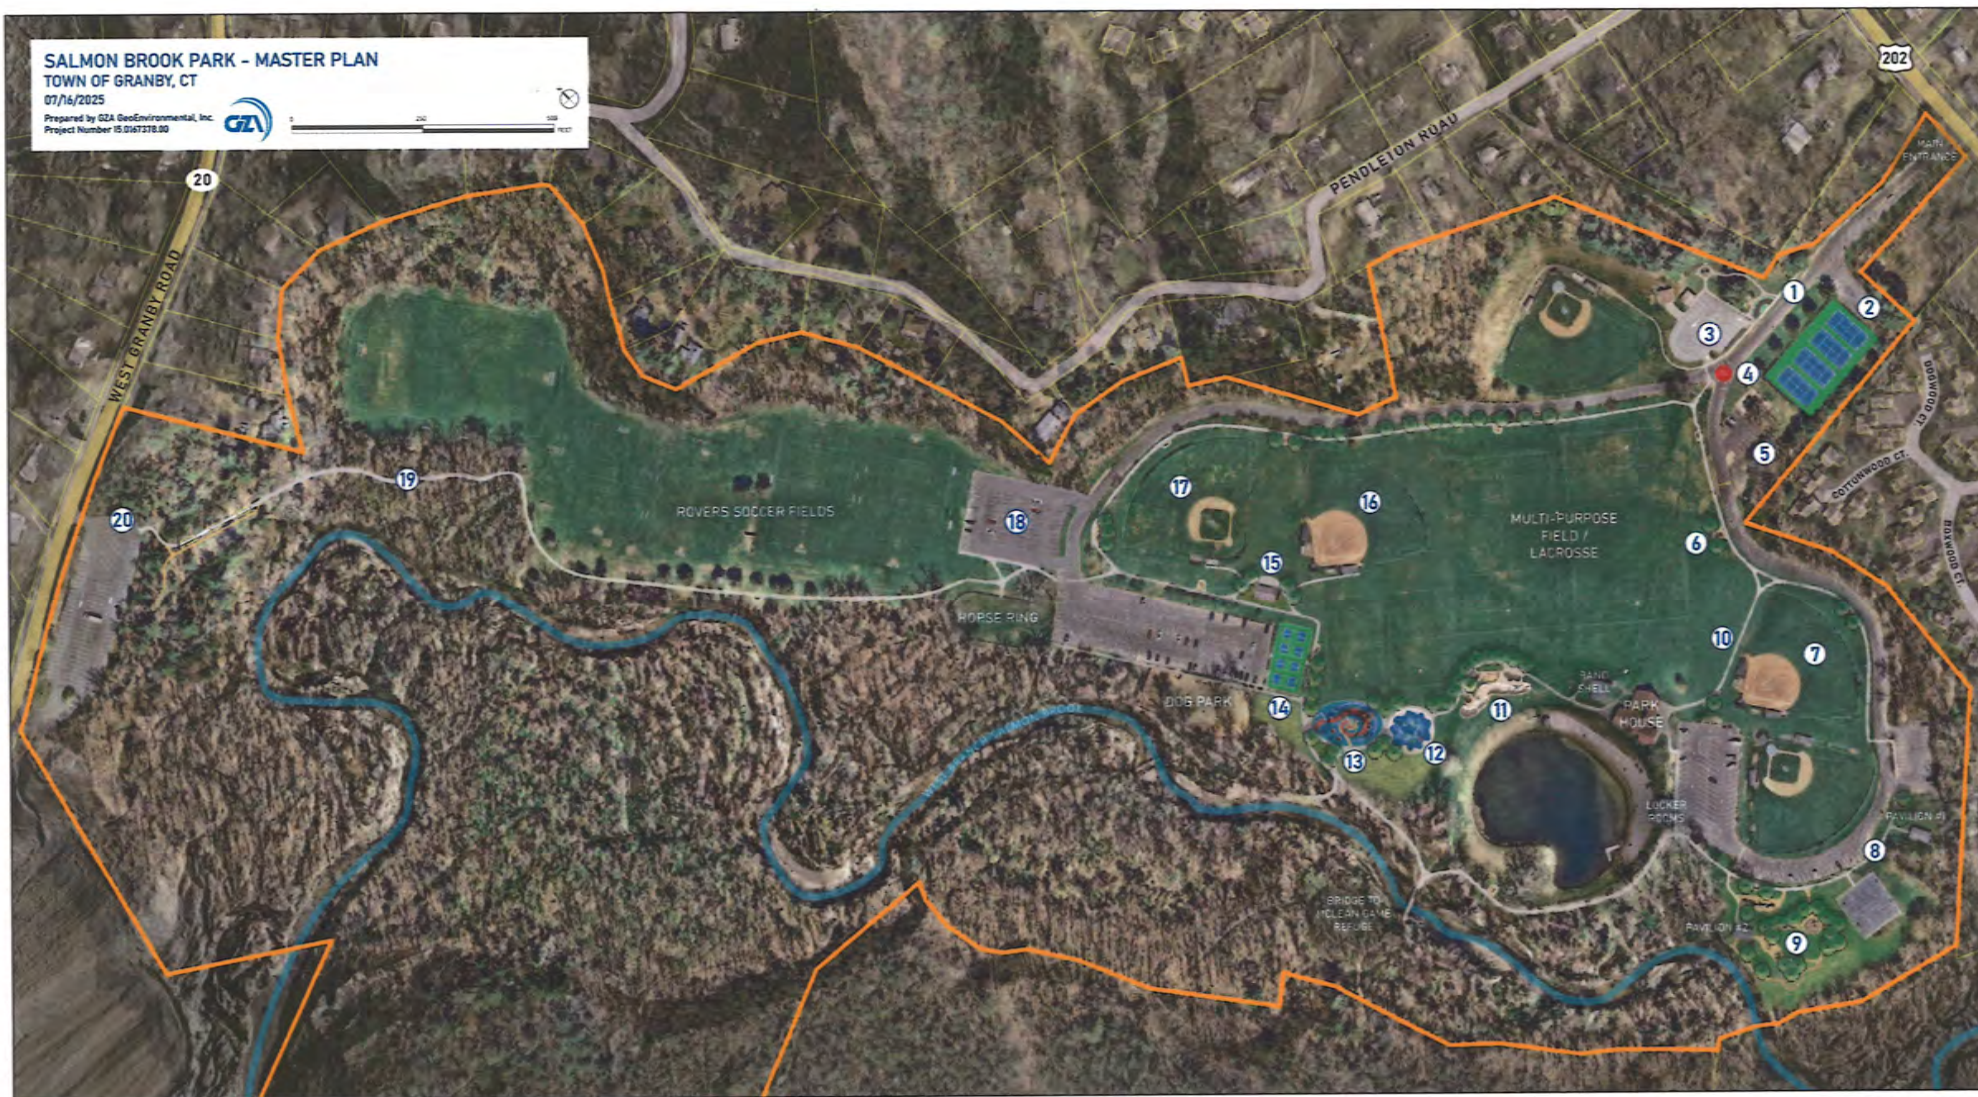
PROPOSED NEW PARK FEATURES AND RECREATIONAL OPPORTUNITIES:

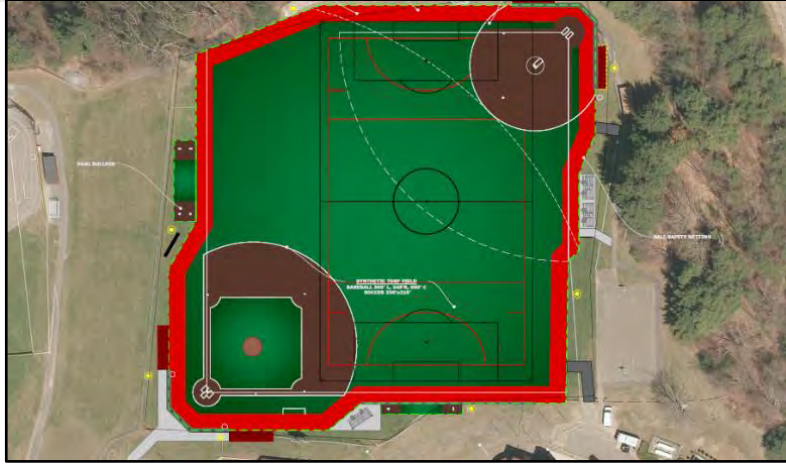
Conceptual Layout

GRANBY MEMORIAL HIGH SCHOOL BASEBALL & SOFTBALL IMPROVEMENTS

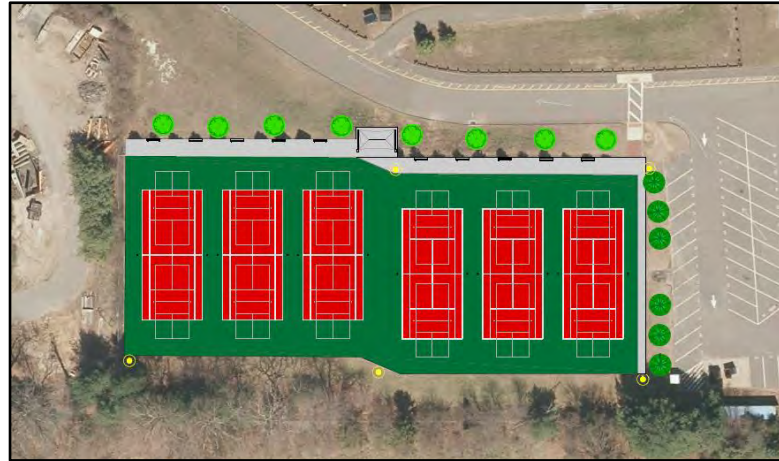
Conceptual Layout

GRANBY MEMORIAL HIGH SCHOOL TENNIS COURT IMPROVEMENTS

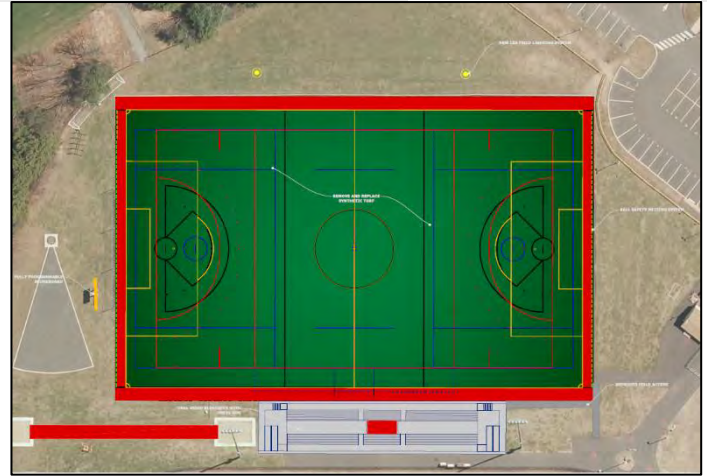
Conceptual Layout

GRANBY MEMORIAL HIGH SCHOOL FIELD 2 IMPROVEMENTS

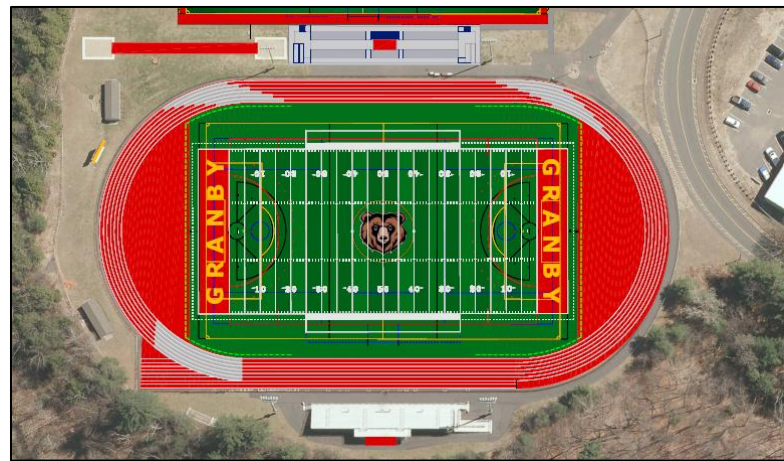
Conceptual Layout

GRANBY MEMORIAL HIGH SCHOOL TRACK & FIELD IMPROVEMENTS
