**CAPITAL PROGRAM PRIORITY ADVISORY COMMITTEE  
REGULAR MEETING  
MONDAY, OCTOBER 6, 2025 – 5 p.m.  
TOWN HALL MEETING ROOM  
5:00 P.M.**

**TOWN OF GRANBY  
CAPITAL PROGRAM PRIORITY ADVISORY COMMITTEE  
SPECIAL MEETING MINUTES  
DECEMBER 2, 2024**

## **Granby Memorial High School Turf Track and Field**

### **Priority Funding for Turf Track and Field Replacement at Granby Memorial High School**

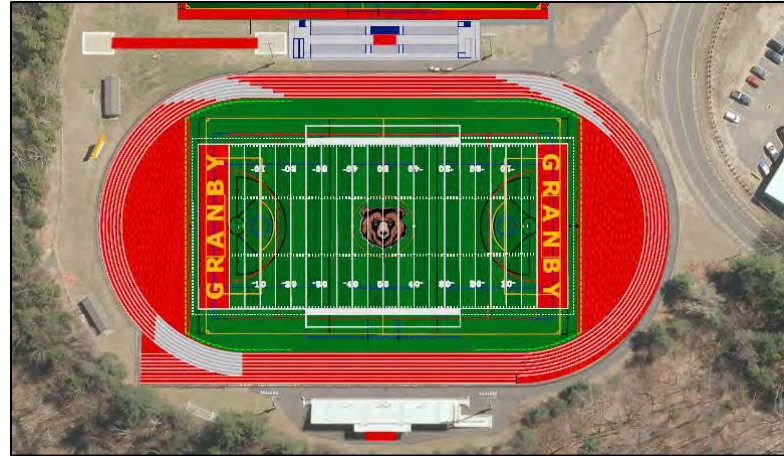
Conceptual Layout

## GRANBY MEMORIAL HIGH SCHOOL TRACK & FIELD IMPROVEMENTS

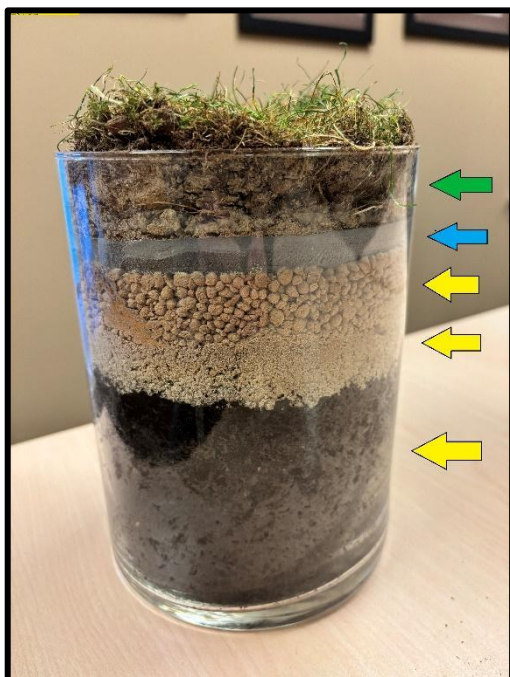
### **Unaffected Turf Field**

The following samples illustrate the existing subsurface conditions at GMHS, with each container representing depths of up to 15 feet.

Properly compacted soil (yellow)

Level base surface (blue)

Level turf surface (green)

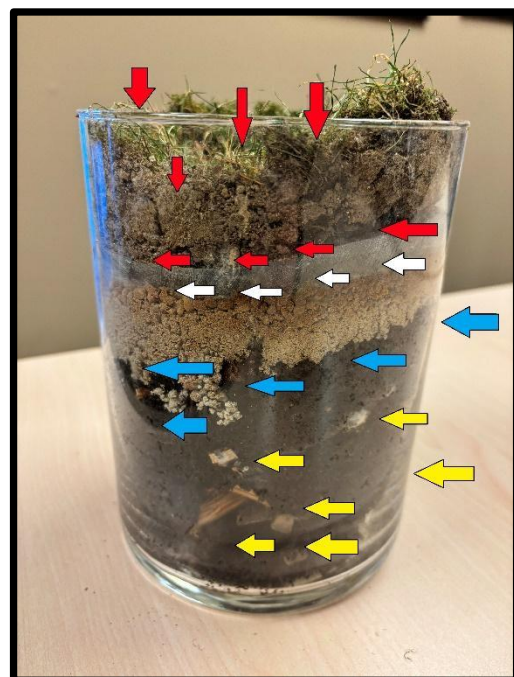
### **Granby Turf Field**

Uncompacted soil w/ pockets of debris and air (yellow)

To ensure long-term stability, experts recommend a comprehensive remediation process, including soil removal, excavation, screening for organic materials, and multiple layers of soil compaction before reinstatement. Without these corrective measures, the risk of additional sinkhole formations in the coming years remains high.

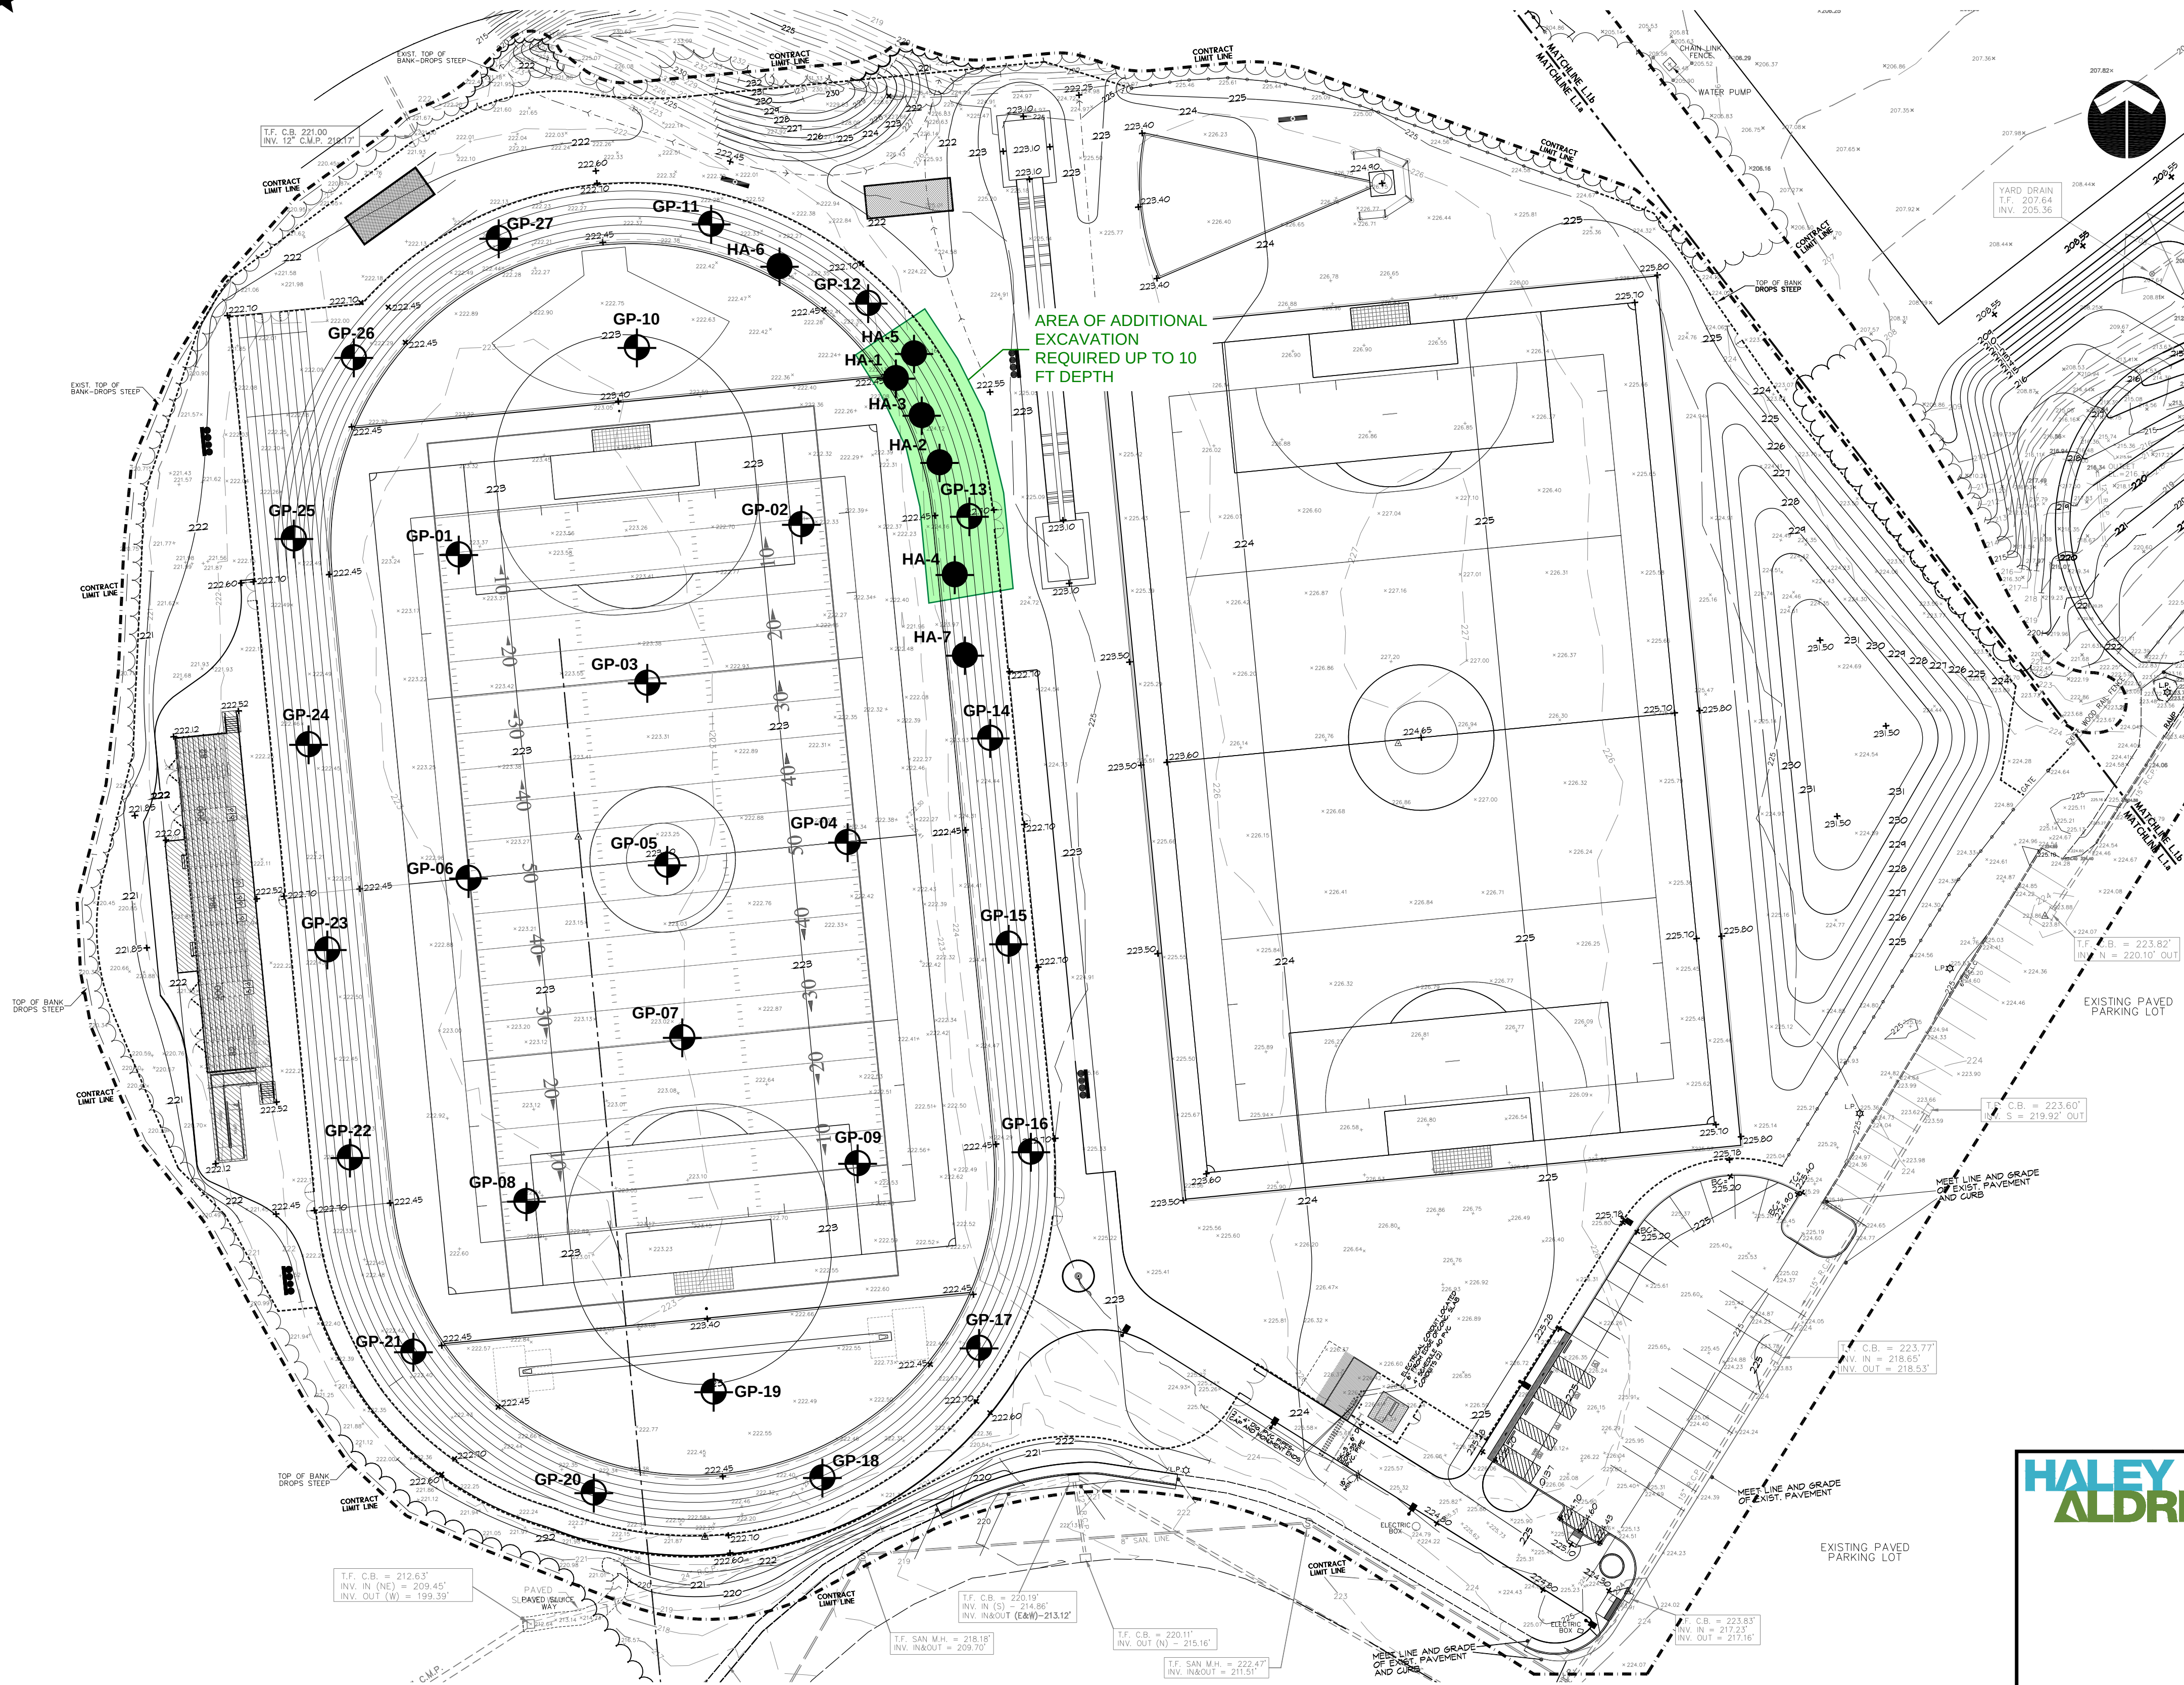
- GP-01 DESIGNATION AND APPROXIMATE LOCATION OF GEOPROBE PERFORMED BY G&M SUBSURFACE FROM 23 TO 25 JUNE 2025 AND OBSERVED BY HALEY & ALDRICH, INC.
- HA-1 DESIGNATION AND APPROXIMATE LOCATION OF GEOPROBE PERFORMED BY SEABOARD DRILLING ON 20 OCTOBER 2022 AND OBSERVED BY HALEY & ALDRICH, INC.

- Figure 1 – Site Locus
- Figure 2 – Site and Subsurface Exploration Location Plan
- Appendix A – Previous Geoprobe Logs
- Appendix B – Recent Geoprobe Logs
